THE  
ECCLESIASTICAL  
ARCHITECTURE  
OF SCOTLAND

FROM THE EARLIEST CHRISTIAN TIMES TO THE  
SEVENTEENTH CENTURY

BY  
DAVID MACGIBBON AND THOMAS ROSS  
AUTHORS OF "THE CASTELLATED AND DOMESTIC ARCHITECTURE OF SCOTLAND"

VOLUME ONE

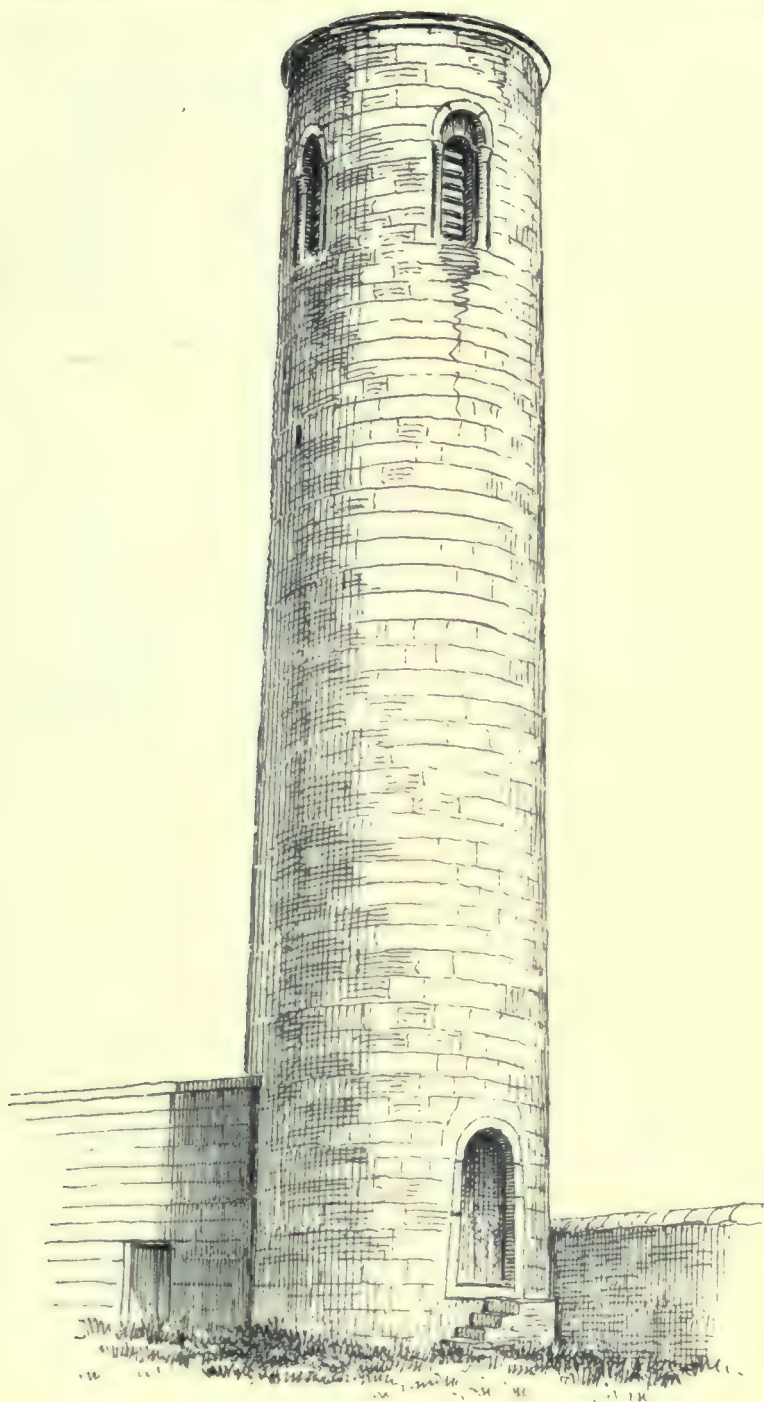
FIG. 114. Abernethy Tower. View from North East.

The masonry of the tower is constructed in regular courses of ashlar work, carefully wrought to the circle. The lower twelve courses are of a hard grey freestone, and the portion above consists of a yellowish freestone of similar workmanship, which is softer, and has decayed considerably both on the exterior and interior. This difference in the materials of the lower and upper portions has led to the belief that the upper part has been rebuilt at a later date than the lower part.

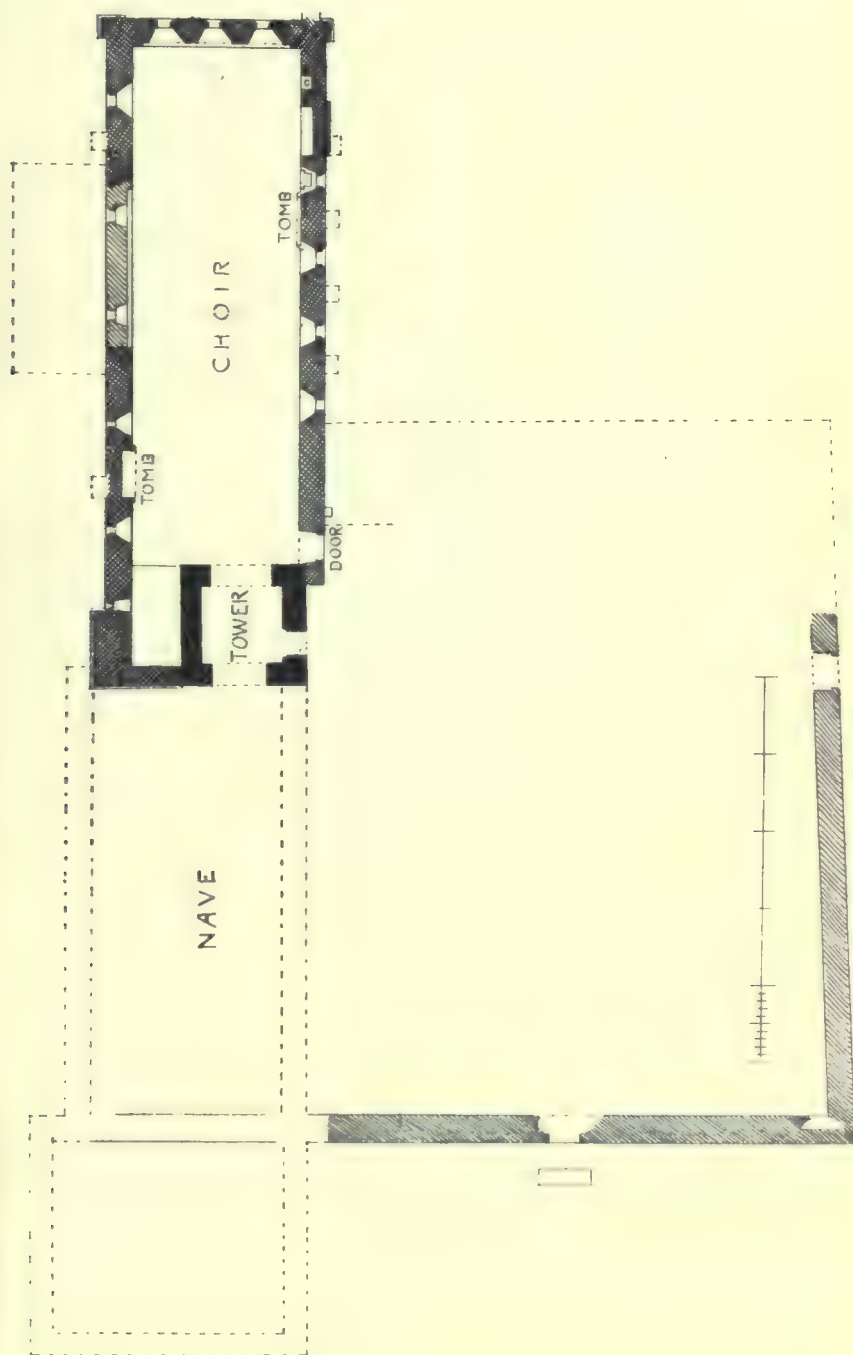
FIG. 145.—Restennet Priory. Plan.

The existing-ruin (see Fig. 145) consists of a choir to the east of the tower. The south wall of this choir probably occupies the original position of the south wall of the ancient church. Assuming that the tower was in the centre of the west wall of the choir, the original church would be about 14 feet wide, and possibly entered through the tower by the narrow doorway in the south side.

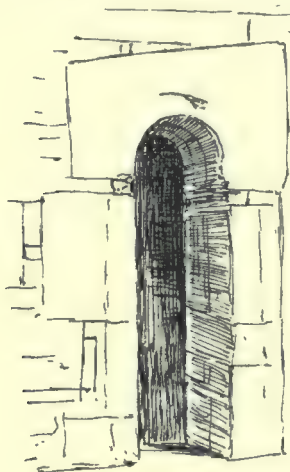
FIG. 146. Restennet Priory. South Doorway of Tower.

The south doorway (Fig. 146) is 2 feet 4 inches wide by about 8 feet high. The soffit of the arch is cut out of single stones. The style of masonry used in the construction of the doorway is peculiar. The thickness of the wall is made up of three courses, the two outer ones being large slabs set on edge, and the interior course being built with smaller stones from a different quarry. The latter are of red and the former of grey sandstone. The outer and inner stones forming the lintel are hollowed out with a semi-circular arch opening. Round the exterior of the doorway there is a raised margin, about eight inches in breadth, with small projection, similar to the margin of the door at Abernethy. Except this ancient feature, there is no other attempt at decoration.

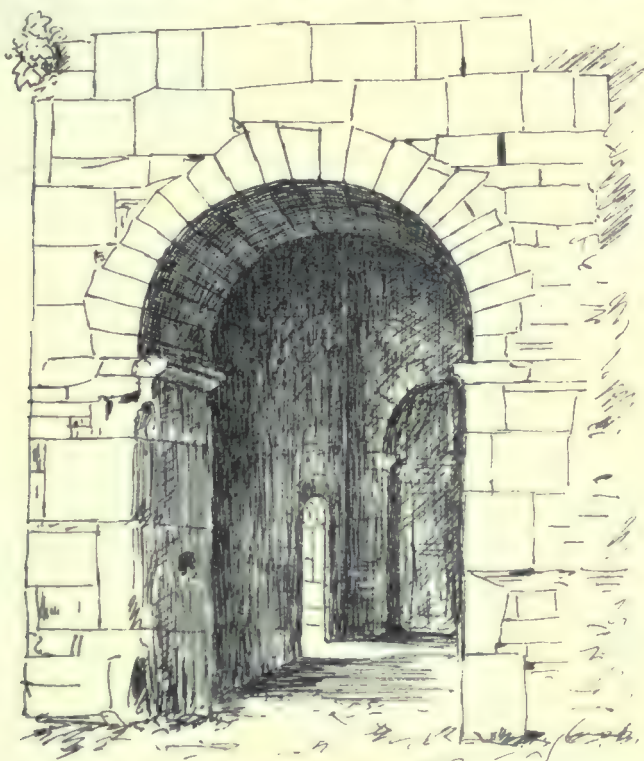
\* FIG. 147.—Restennet Priory. Archway in East Wall of Tower.

The arch in the east wall (Fig. 147) is 8 feet 4 inches wide, and is stated by Mr. Galloway\* to have been 15 feet 8 inches high from the original floor level to the soffit. The space comprised within the tower

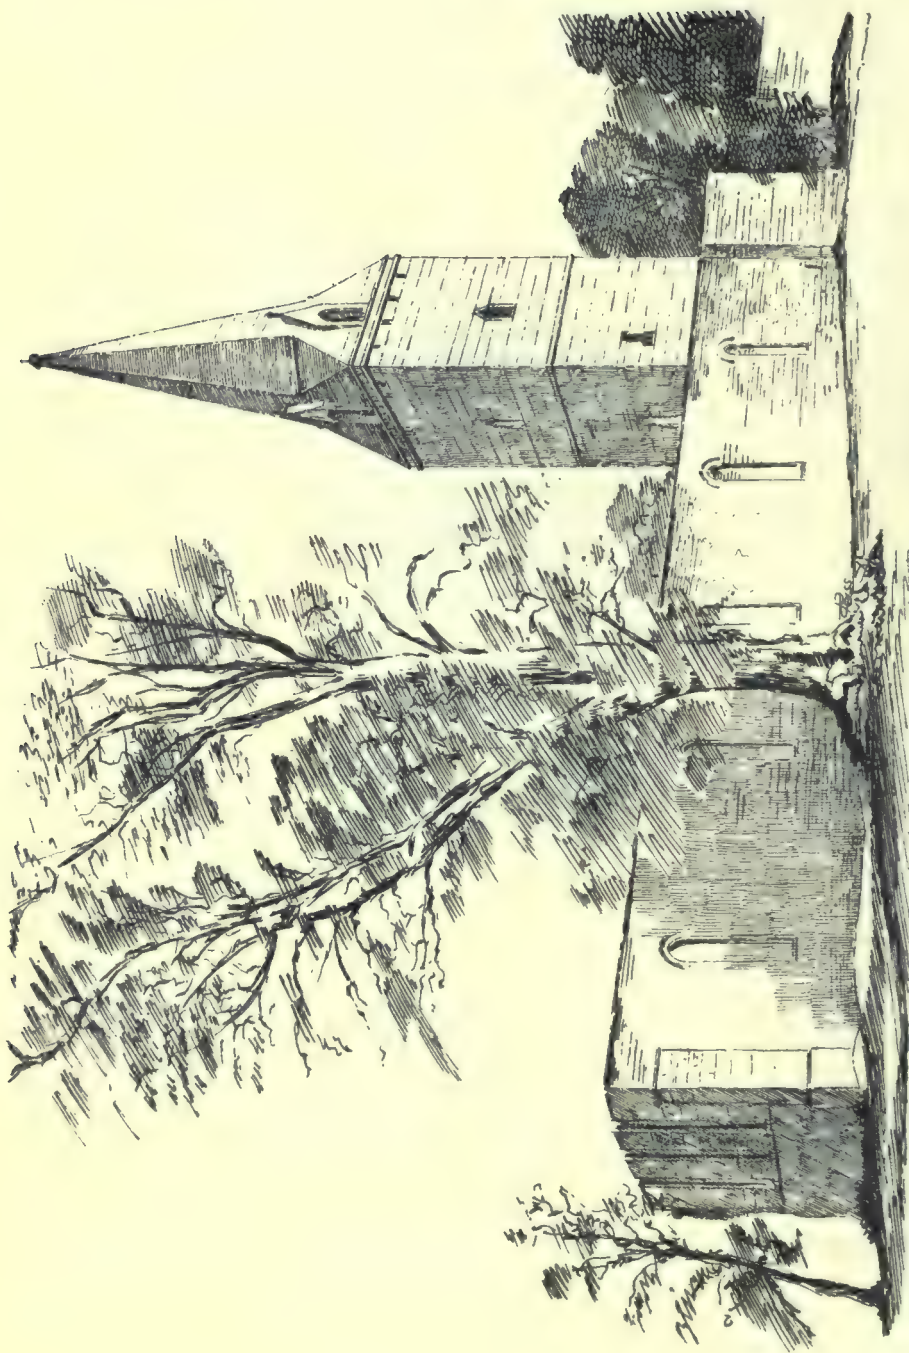
FIG. 148.—Restennet Priory. View from North-East.

Above the arches just described, the tower contains two stories (Fig. 148). In the first story there is a small opening on the east side, about 1 foot 8 inches wide and 4 feet 8 inches high, contained within the space of the choir roof; and on the south side there is another opening, about half this size. A small round opening, a few inches wide, in the west wall (Fig. 149) completes the lights on this story. The highest story, which is separated from the one below by a string course, contains an opening with a straight-sided arch on each face, and each of these openings has an external back-set fillet or margin.

accounts for the absence of the buttresses and of the hood mouldings of two of the rebuilt lancet windows on the north side (see Figs. 148 and 149). On the south side, the buttresses have all been pulled down, but otherwise the wall remains intact, with first-pointed corbels along the top of the wall. In the east wall, the apex of which is gone (Fig. 150), there were

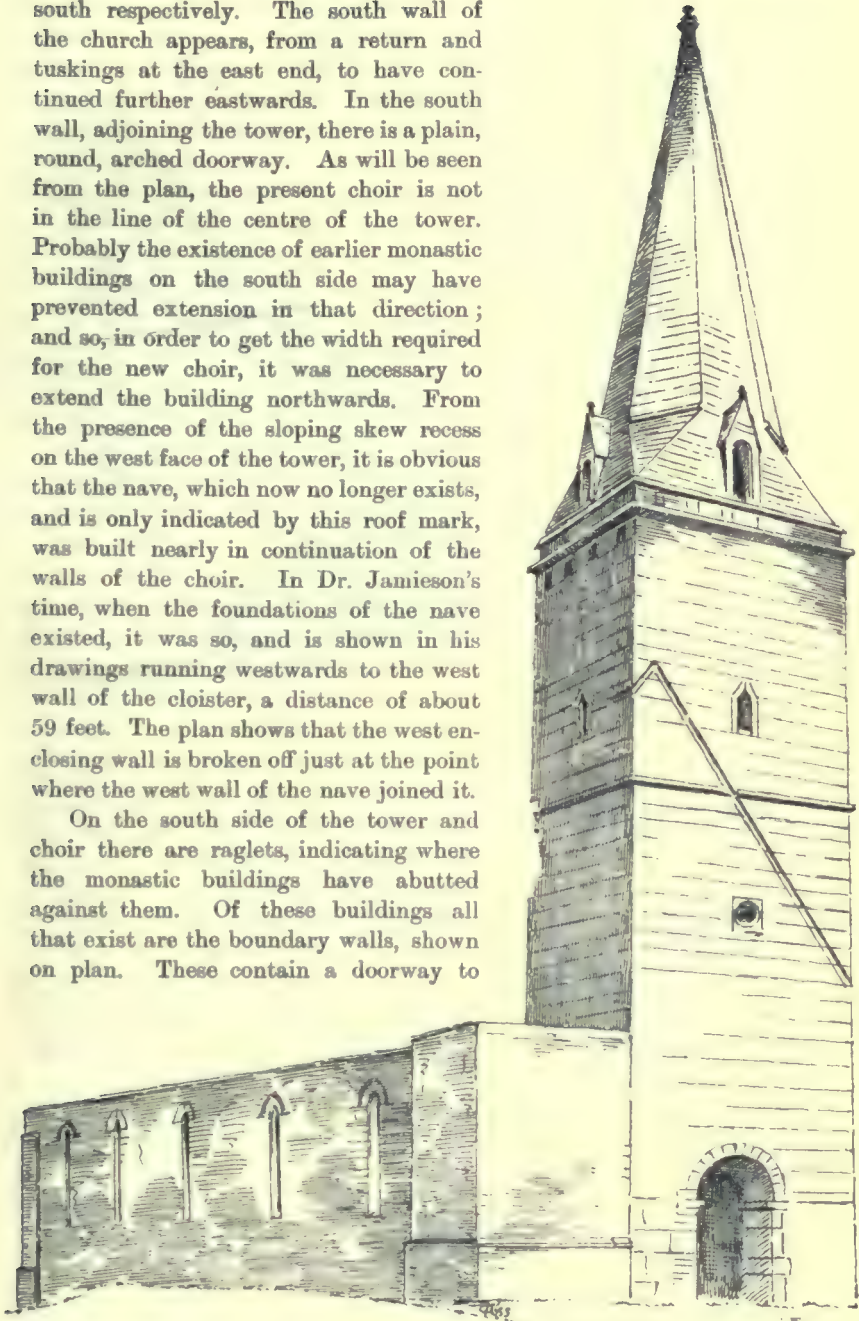
FIG. 149.—Restennet Priory. View from North-West

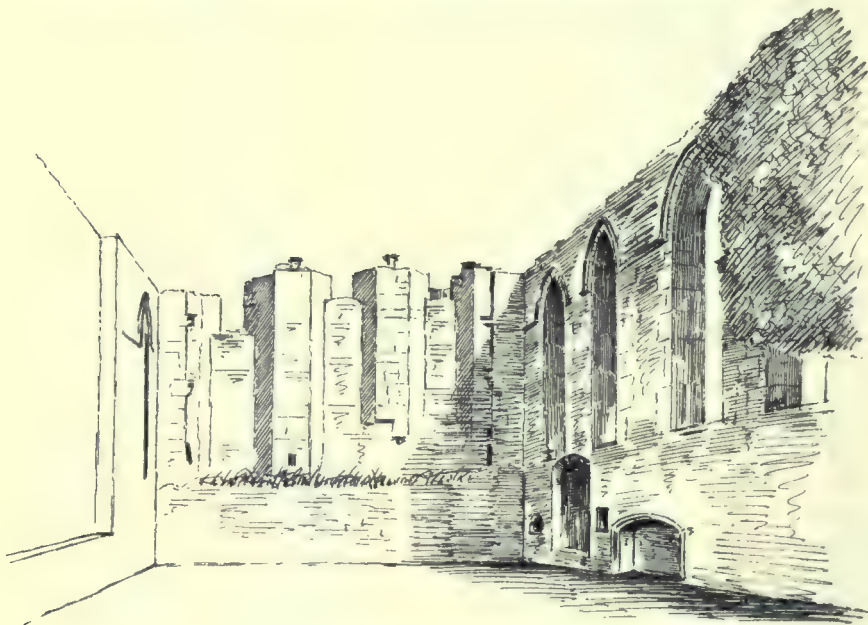
FIG. 150.—Restennet Priory. Interior of East End.

three lancet windows, which had banded nook shafts in the interior, and a simple splay externally. At the east end, on the south side, there is a piscina (Fig. 151), a sedilia recess, a locker, and a tomb of late work. On the north side there has been a similar recessed tomb, now built up. The font shown in Fig. 152 is lying inside the choir, but its base is gone. It measures 2 feet 4 inches in external width by 1 foot 9 inches inside, and 18 inches high, with a square hole in the centre. It appears to be of late date.

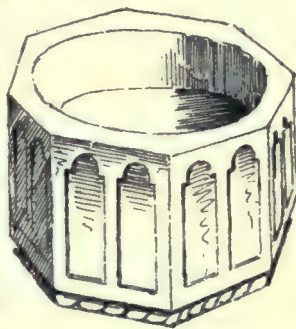
FIG. 152.—Restennet Priory. Font

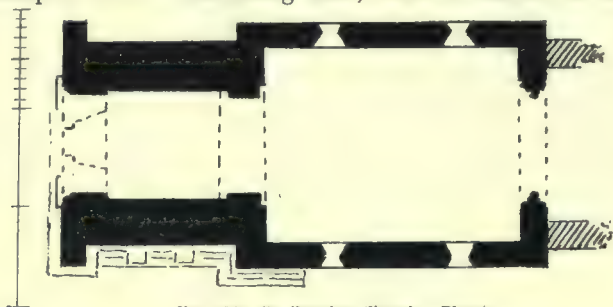
FIG. 153.—St. Regulus Church. Plan.\*

\* The lines on south side of tower show foundations now exposed, and a built-up door in south wall of tower is not shown, being apparently not original.

The edifice (Fig. 153) consists of a chamber 26 feet long and 19 feet 10 inches wide internally, with walls about 34 feet high. The great height of the building, as compared with its width and length, is one of the points which connect it with the pre-Norman structures of Northumbria. There appears to have been an eastern apse, of which only portions of the foundations next the main structure now remain. A lofty square tower (Fig. 154) at the west end of the oblong chamber is the most striking feature of the building. It is about 110 feet high, and measures about 21 feet 4 inches square over the walls.

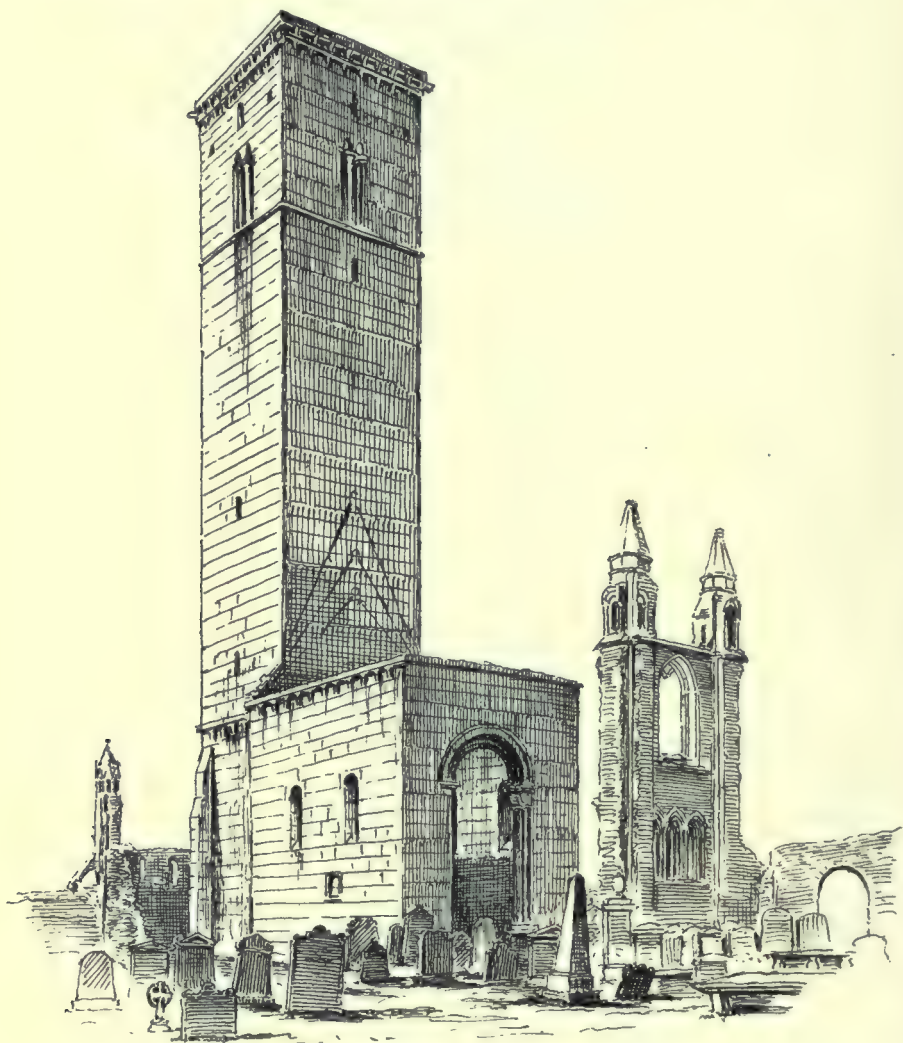
FIG. 155.—St. Regulus'. View from South-East.

At the east end of the main building a lofty archway (Fig. 155) opens towards what was probably the apse. The opening is 9 feet wide by

25 feet 6 inches high. Each jamb has three attached shafts (Fig. 156), with somewhat rude caps and bases, and bold mouldings in the arch. The existence of this archway clearly indicates that there was a building

The chancel is lighted by four windows, two on each side, placed at about 14 feet above the ground. (See Fig. 155.) They are round headed, the circles being cut out of a single stone on the outside, but arched on the inside. The openings are 6 feet 6 inches high and 1 foot 10 inches wide, and have broad splays internally.

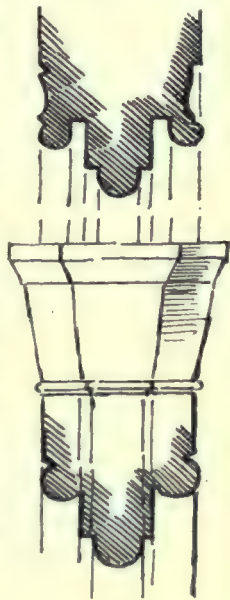
FIG. 156.—St. Regulus'.  
Details of East Arch.

The arch opening from the chancel to the tower is 9 feet 10 inches wide by 27 feet high, and is of a plainer description than the apse archway. The jambs have a square recess or nook on each face of the wall with a shaft in each recess ; and the arch above is quite plain, with square edges. The western arch, from the tower into the supposed nave, is shown in Fig. 154. It is 10 feet 4 inches wide by 28 feet high. Both of the archways in the tower are now built up. The moulding of the west arch, as far as visible, is shown in Fig. 157. The capitals of all the shafts are rather shapeless and clumsy, but the necking and arch mouldings are of good design. The arches are all slightly of the horse-shoe form.

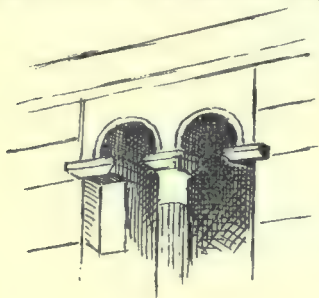
FIG. 158.--St. Regulus. Belfry Window.

The building has a cornice at the wall-head, containing a series of simple corbels. A string course runs round the tower below the top story, and above it there is a belfry window on each face, about 3 feet wide by 8 feet 9 inches high. Each window is divided into two openings by a rounded centre shaft (Fig. 158), and there were round nook shafts at each side, but these have now fallen away. There are a few small openings on each face at different stages. The tower is crowned with a cornice, having two rows of simple corbels similar to those of the chancel cornice. On the east side there is an opening into the space which was covered by the chancel roof. The floors of the tower have been of timber, and there is one set-off in the inside of about 6 inches, at a height of about 64 feet. There was no access stair. At the north-west corner of the chancel, and at the wall-head level, there are two caps which have a very distinct appearance of being of first pointed date.

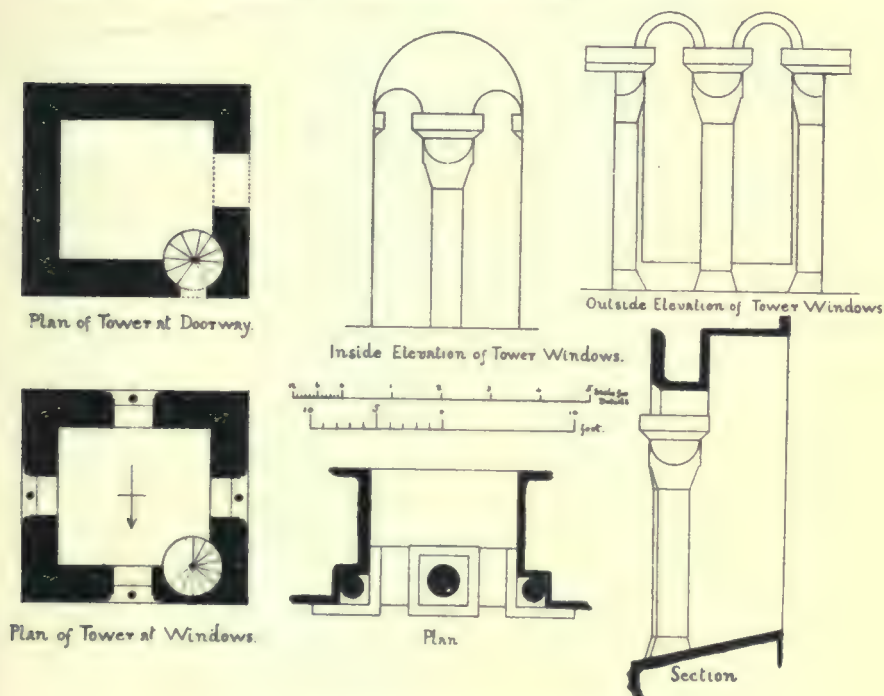
FIG. 159.—Markinch Church Tower. Plans and Details.

It is nearly square on plan (Fig. 159), being 16 feet from north to south by 17 feet from east to west. The tower rises (Fig. 160) without a break (except a string course at each floor) to the height of four stories,

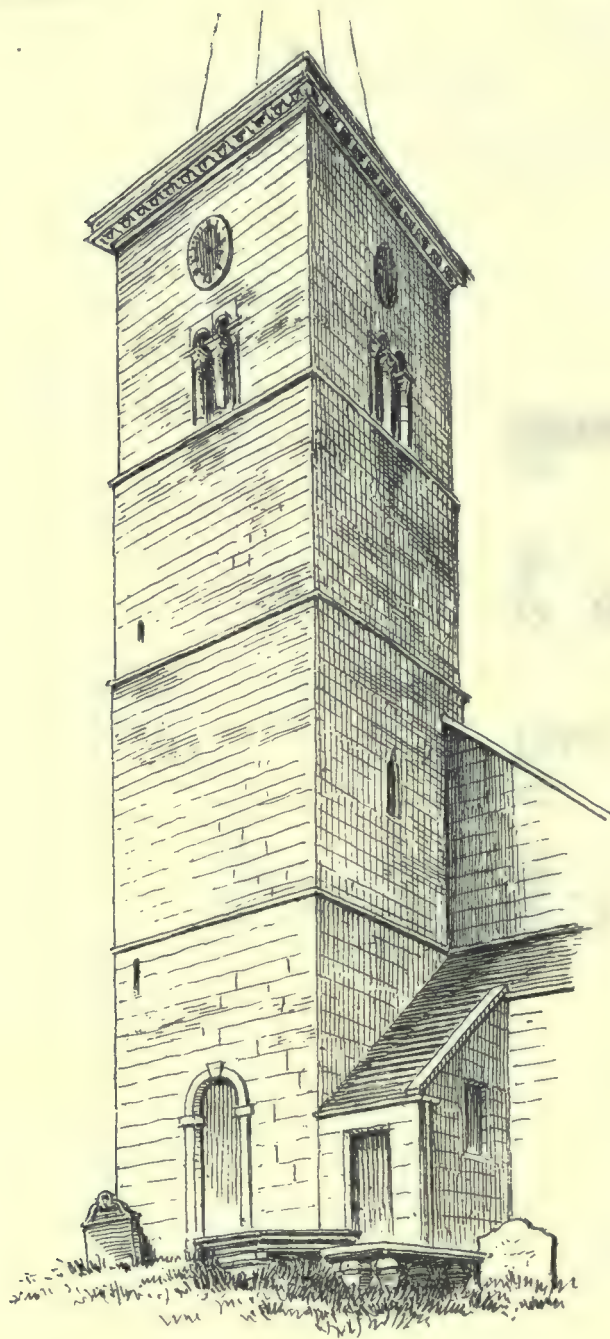
FIG. 160.—Markinch Tower. From South-West.

or 73 feet to the top of the parapet. The original entrance (Fig. 161) is by a door, two feet wide, at the north-west angle. The sill is now about two feet above the ground, but it doubtless stood several feet higher originally. From the doorway a wheel stair leads to the upper floors. The stair and upper floors were lighted by small windows, with round heads. These are now built up, except one in the south side, which has been changed into a trefoil head. The top story is lighted by a window in each face. Each of these windows (see Fig. 159) consists of two openings, divided by a central shaft. On the exterior each opening is arched, with a small semi-circular arch, cut out of one stone; but in the interior both openings are spanned by one arch. The arrangement of the shafts is peculiar, the central shaft being placed so as to be in the centre of the abacus which carries the small arches, while the side shafts are wrought upon the angles of the jambs, and do not stand in the same plane as the central shaft. The caps are Norman, of the usual cushion form, with heavy abacus; but they and the bases are now much decayed.

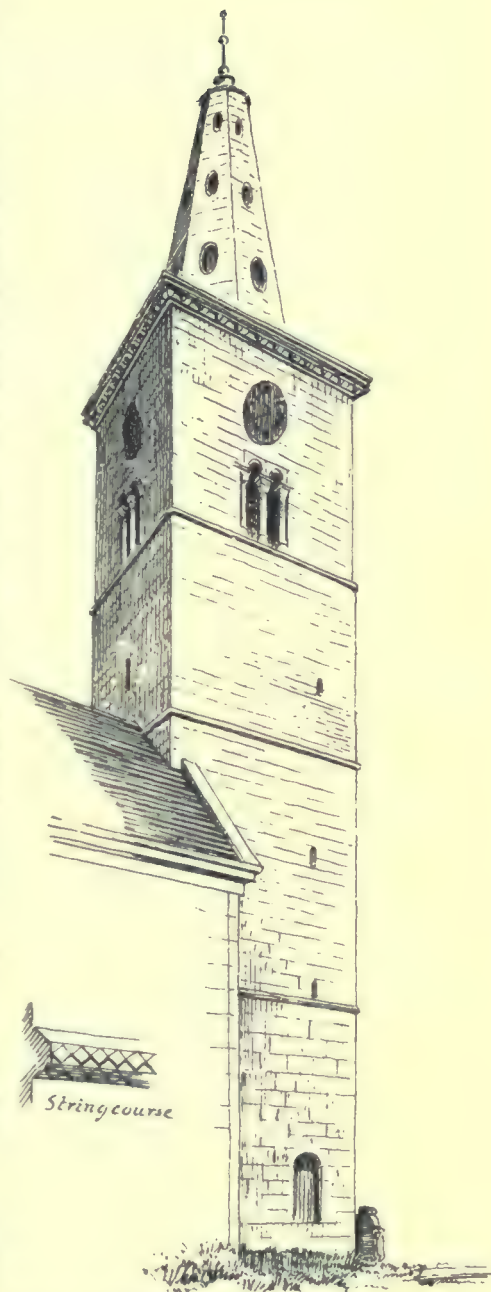
FIG. 161.—Markinch Tower. From North-East.

carved with the ordinary Norman enrichment of the lozenge (see Fig. 161). These are now nearly wasted away. The church attached to the tower is entirely modern, and a modern doorway of entrance has been cut through the tower.

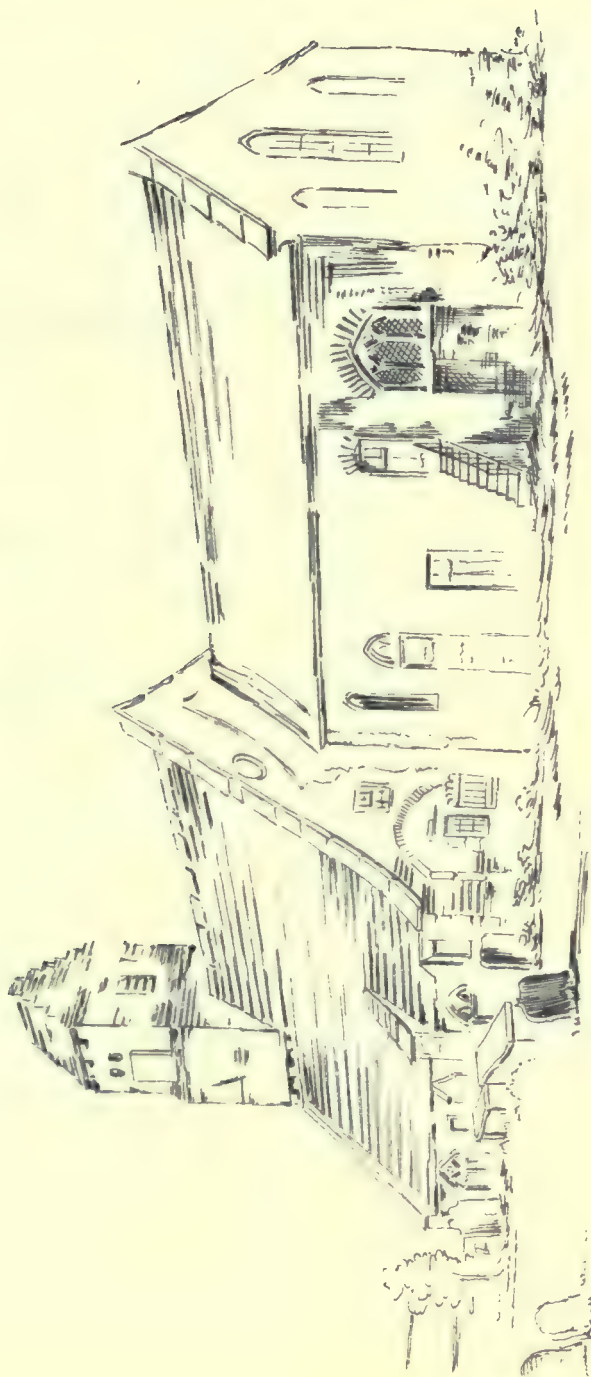
FIG. 162.—Muthill Church. From South-East. (From Sketch by Nattes, about 1799.)

The parish of Muthill lies about three miles south of Crieff. The ancient church, with its venerable tower, remained entire and in use as the parish church till about the year 1818, when, unfortunately, it was abandoned for a new building erected about that time. We are enabled to give a view\* of the old church (Fig. 162), made by John Claude Nattes about the year 1799, from which it will be seen how eminently picturesque the old structure was, and how deplorable is the ruin which has overtaken it in the last half-century.†

† The sketch is a very slight and hurried one, and is not at all finished in detail; but it is enough, when taken with the other drawings, to enable a fair idea to be formed of the completed church. The tower has had a clock dial, placed so as to conceal the south windows. The traceried windows of the south aisle of the nave are indicated, along with the lintelled doorway and a raised window, which may have been over an outside stair in connection with a gallery. The east window of the aisle is shown built up, with a square shuttered window inserted where the mullions formerly were, and the small window above has been enlarged for light to the gallery. The view of the chancel is particularly interesting, this part of the church having now almost disappeared. In the choir a mullioned window of three lights is shown above the sedilia, and a small door is knocked through the latter. The east end is shown lighted by three simple lancet windows.

The roof of the church is shown on the sketch by Nattes as being in one span; so that there does not appear to have been a clerestory over the nave arcade. Now only the foundation of the north aisle wall remains, and the chancel walls are reduced to a few feet in height; while at the west end they have almost disappeared, showing how badly used the place has been during this century. The entrance to the church was by a square-lintelled doorway in the centre of the south wall of the nave, and there appears to have been a priests' doorway in the south side of the

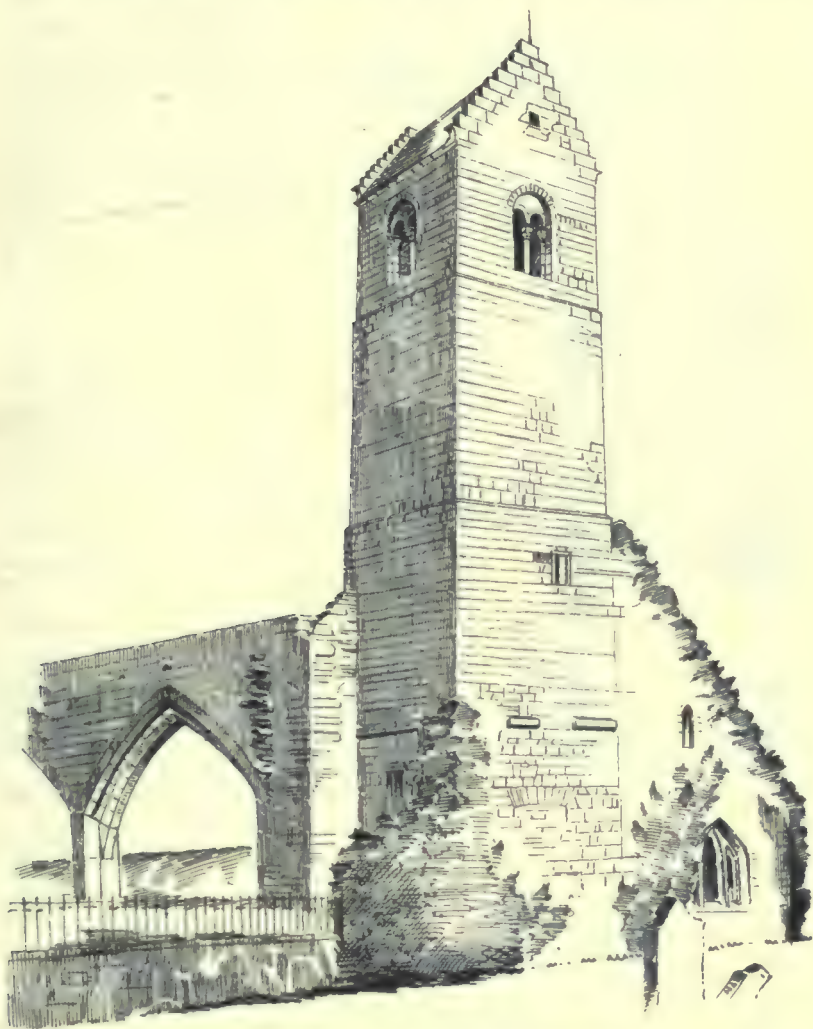
FIG. 164.—Muthill Church. View of Tower from North-West.

The belfry stage has an opening in each face. Those on the west and north sides (see Fig. 164) consist of large arches, each containing two smaller ones. They are alike, and measure about 3 feet 5 inches wide on the inside by about 5 feet 10 inches high to top of large arch, and about 4 feet 2 inches of daylight. They are divided with a central octagonal shaft, with round responds set well back in the wall. The shafts have all cushion capitals, those of the responds being slightly higher than those of the central shafts. The arches springing from these caps are very rudely formed. Each of these two windows is wider at the springing of the arch

doubtless stood here, cannot now be ascertained. There seems to have been a doorway on the west face of the ground floor (see Fig. 164), about 4 feet wide, formed with a flat arch about 7 feet 6 inches above the present level of the ground ; but it is doubtful if the door came to the

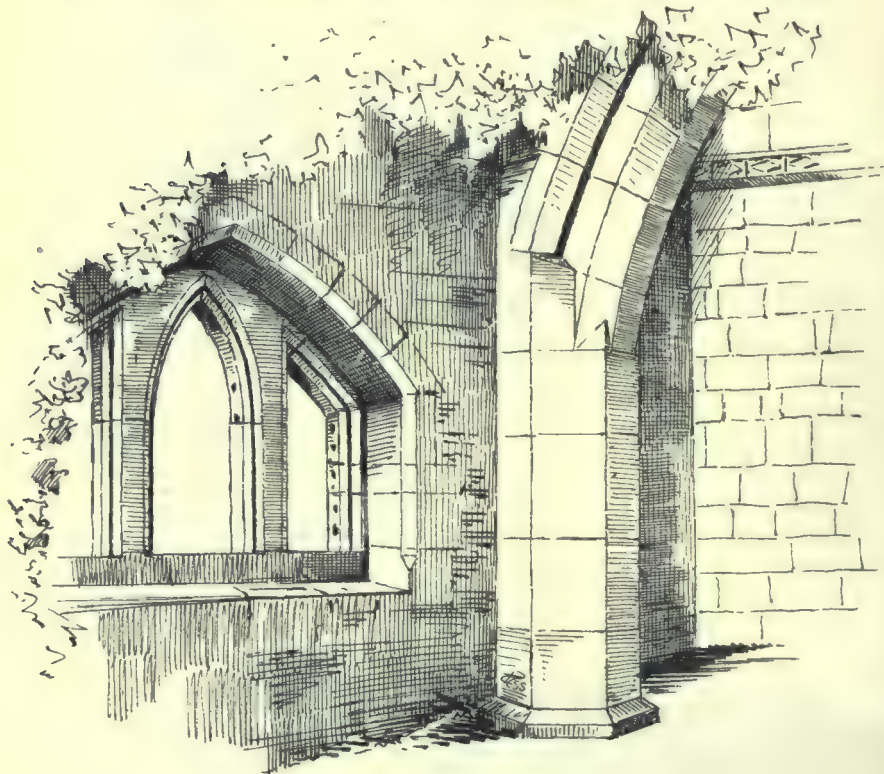
FIG. 167.—Muthill Church. West Window and Respond.

end of the north aisle there seems to have been a chapel, lighted with a west window.

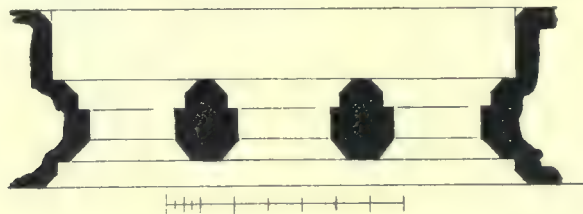
FIG. 168.—Muthill Church. Plan of Windows in South Aisle.

aisle (Fig. 168), contain three lights in each. They are of good design, and resemble windows in the north side of Dunblane Cathedral. The east window in the south aisle of the nave is completely demolished, and only one jamb remains of the west window of the north-west chapel. Over each of the end windows of the south aisle there are small pointed windows, widely splayed towards the inside. One of these is shown in Fig. 164. An ambry at the east end of the south aisle, and a roughly-formed recess or ambry on the north side of the chancel, with the remains of a *sedilia*, complete the ecclesiastical appurtenances of the church, so far as they have been spared, if, indeed, the latter can be said to have been spared.

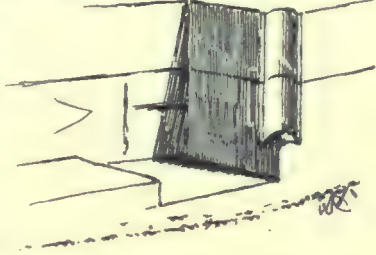
FIG. 169. — Muthill Church. Remains of *Sedilia*.

It is situated in the usual place, near the east end of the chancel; but only a portion of the west corner remains. (Fig. 169). It is moulded, having a hollow set in a splay, with a stop chamfer above the seat level. How it was finished along the top nothing remains to indicate. There were three seats, graduated in height—an unusual feature in Scotland. The lowest seat, which is 1 foot 11 inches wide, is the narrowest; the centre one is 2 feet 3 inches; and the east one appears to have been the widest, but, the wall being broken down, the exact dimensions cannot be given.

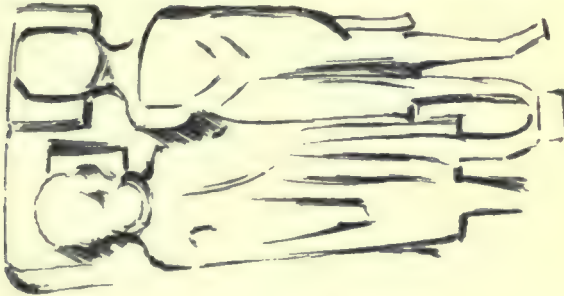
FIG. 170. — Muthill Church. Monument.

Opposite the *sedilia* are the mutilated remains of two figures. (Fig. 170). They are life-size, and are cut out of one stone. They have

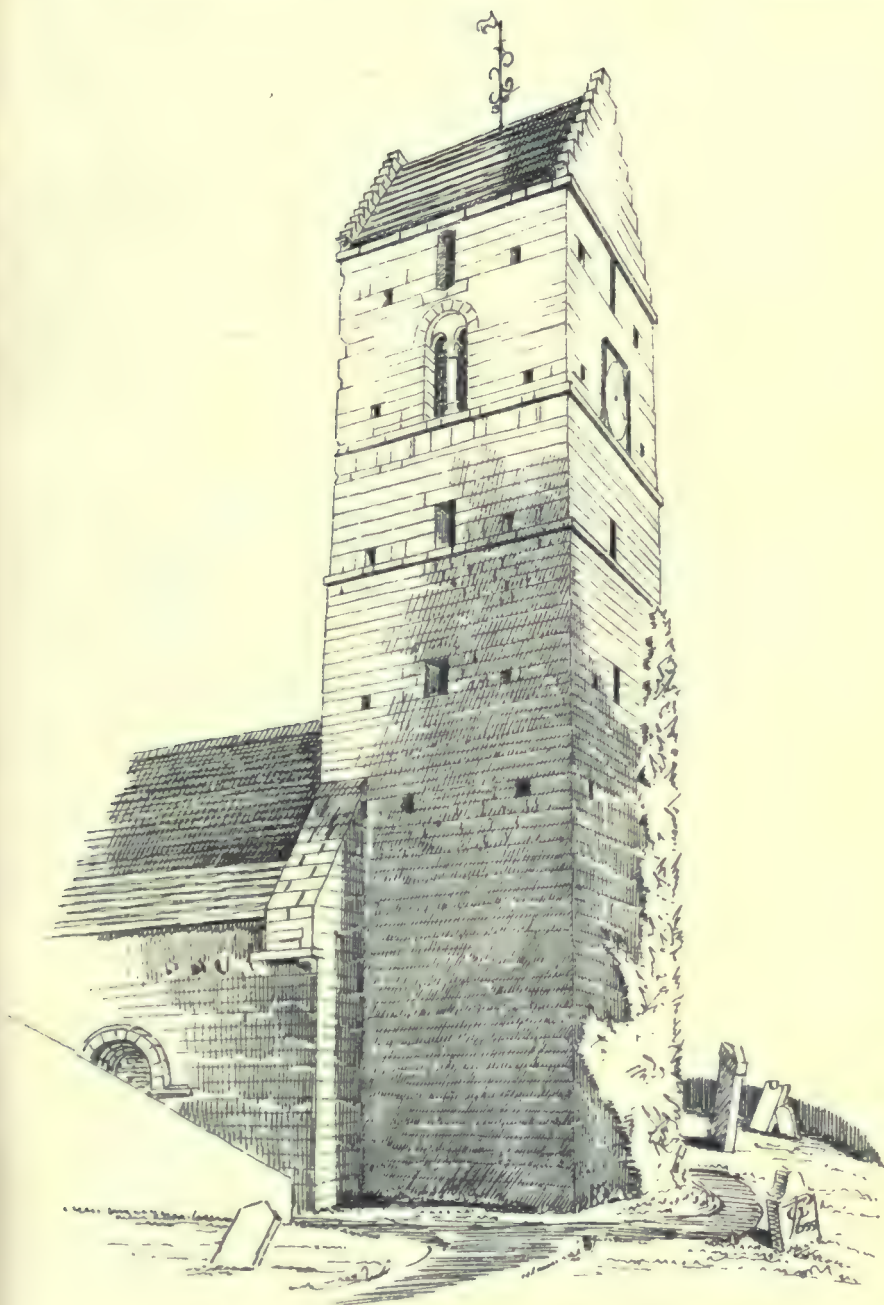
FIG. 171 — Tower of St. Serf's, Dunning. From North West

The tower (Fig. 171), which is of Norman architecture, is placed at the west end of the church (Fig. 172). It is built in three unequal tapering stages, and without buttresses, to a height of about 75 feet to the ridge. The two stories above the church roof have small square-lintelled windows, but in the belfry stage double windows are introduced (Fig. 173). Both lights are contained within a plain square-edged round arch, without imposts, and the two lights, which have plain round arches, are separated by a central shaft with cushion cap. The crow-stepped gables of the saddle-backed roof are probably of later date, but they, no doubt, indicate the original style of finishing the tower. The turret stair, shown on plan (see Fig. 172) stops about half-way up, access above being obtained by wooden ladders. The elaborately-carved and pointed archway (Fig. 174), opening from the tower into the church, is a most noteworthy

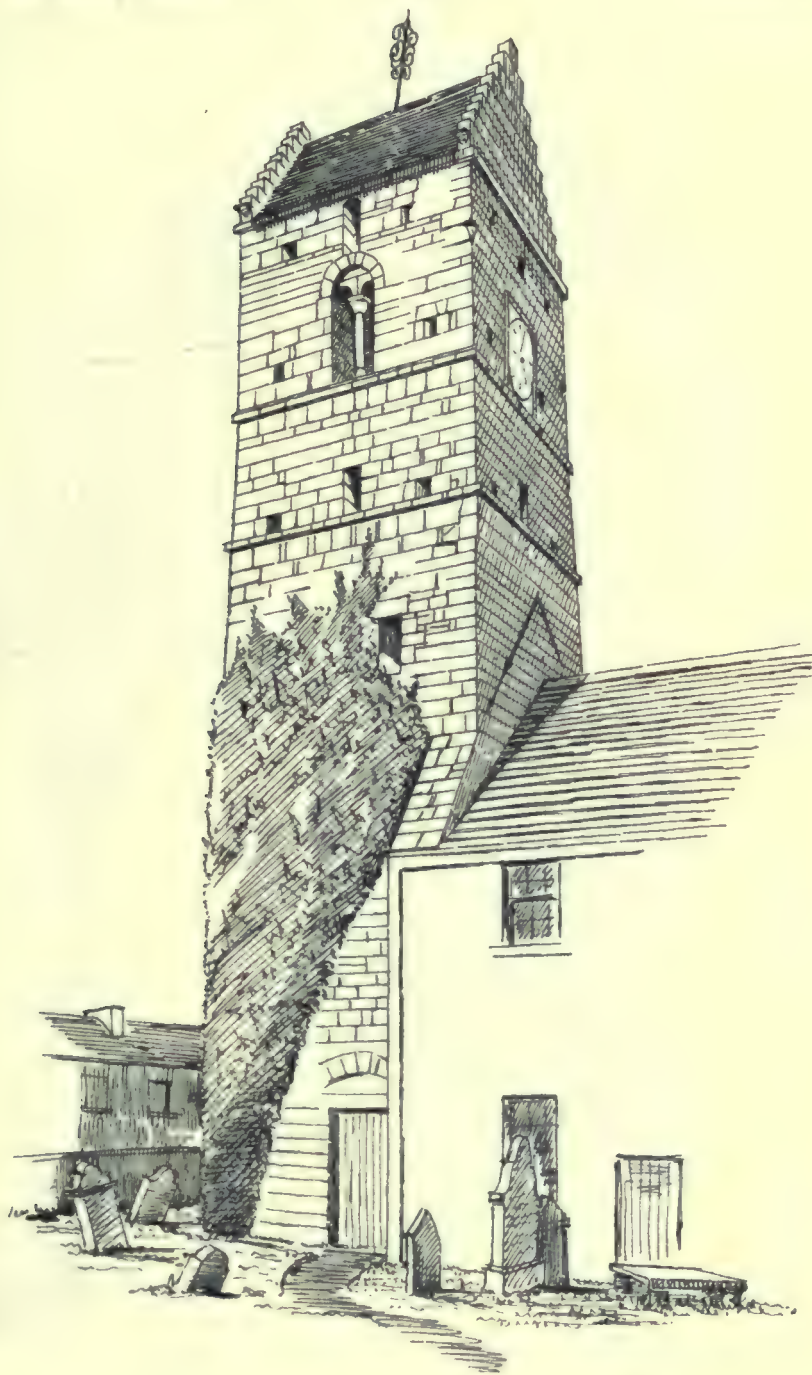
FIG. 173. St. Serf's, Dunning. South East View of Tower.

still survive (see Fig. 178), and the raggle of the original roof is seen against the east side of the tower (see Fig. 173). It is thus quite evident that the existing building is in great part on the site of the *Ecclesia*

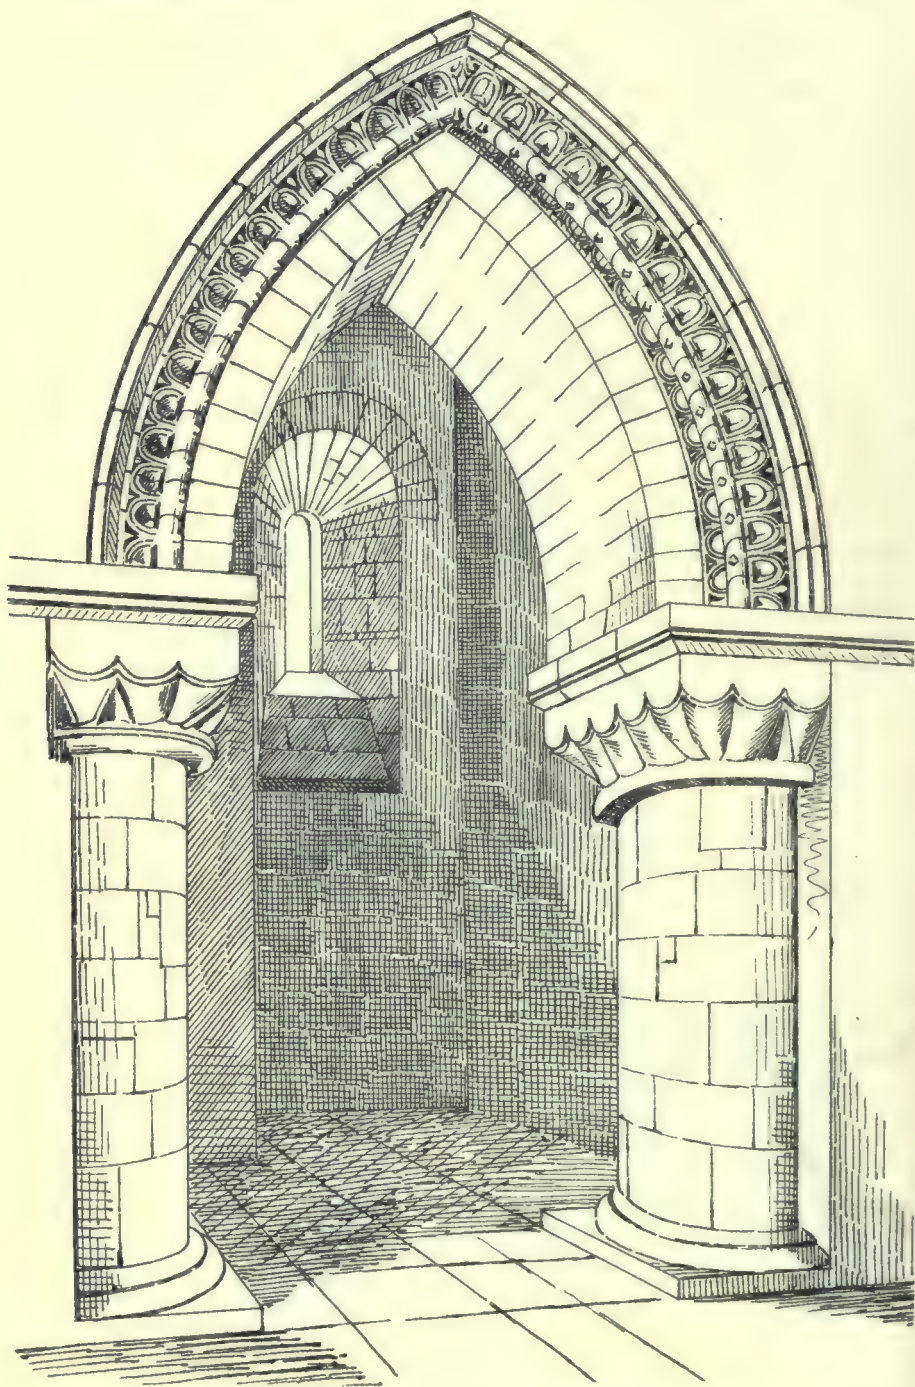
FIG. 174.—St. Serf's Dunning. Archway in Tower.

feature, and was quite concealed from view till disclosed during the course of some recent repairs. Figs. 175, 176, and 177 show the details of this archway.

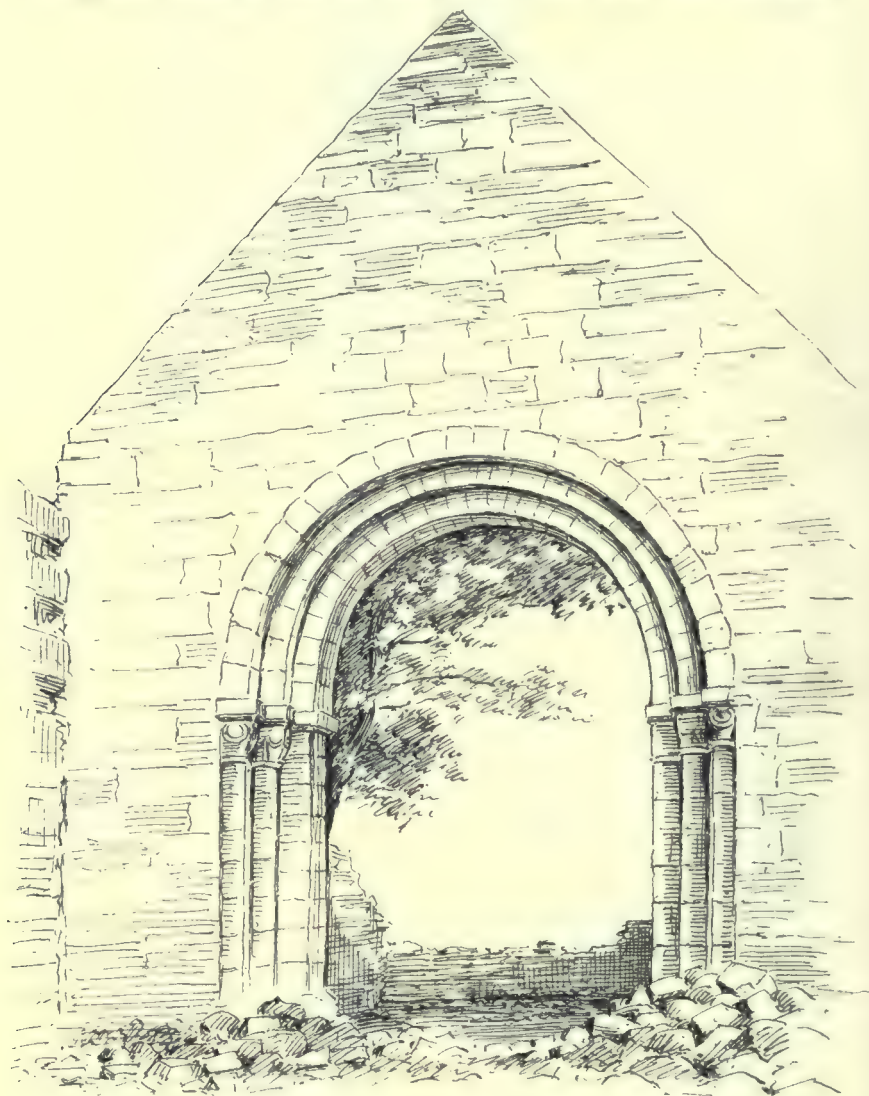
FIG. 179.—Cruggleton Church. Chancel Arch, from West.

and about the same distance from Whithorn, to the priory at which it belonged before the Reformation. The church of Cruggleton, being abandoned, fell into decay. The view (Fig. 179), for which we have to thank Mr. Galloway, shows its condition before it was recently restored by the Marquis of Bute, under Mr. Galloway's careful superintendence. The building is still surrounded by its burial-ground. The plan (Fig. 181) shows a simple oblong church, 34 feet in length by 20 feet in width, with an oblong chancel 20 feet 3 inches long by 16 feet wide. The side walls were considerably damaged, but enough of them remained

to enable the outline to be distinctly traced. The best preserved and most important feature was the chancel arch, which was 8 feet in width. Its architecture, which was extremely simple, was of the early Norman style. It had three orders on the side next the nave (see Fig. 179), each side having two nook shafts, built in courses and provided with cushion caps. The inner jambs were plain, and the aperture in the wall was simply faced with a square ingoing of ashlar, and enclosed on the side next the chancel (Fig. 180) with a single square-edged arch springing from a very plain impost.

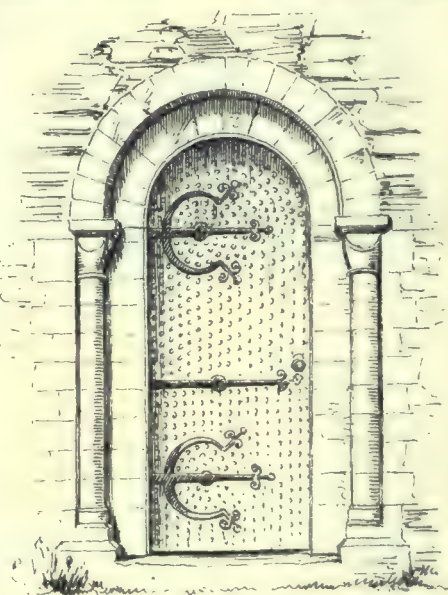
FIG. 182.—Cruggleton Church. North Doorway as Restored.

also remained. Of the external features there seemed at first to be no trace. The discovery of one stone threw a flood of light on it. This was the base of a column which had never been shifted out of its position, but simply lifted and laid on its side, with the bottom bed outwards, so as to look like an ordinary courser. I also found about the same place several plain arch stones, also a capital of simple form, and from these materials, and especially the base found *in situ*, there could be no doubt that the external features were a plain ring like that of the chancel arch carried on engaged columns. In taking down some of a dry stone dyke a large rybat and an arch stone checked and chamfered were found, which could only be part of the actual doorway. The only uncertainty is the height; the original may have been lower, but we cannot be certain. I adhered to the proportions usual in other examples." Fig. 182 shows the restored doorway, "a recovery out of the long forgotten past."

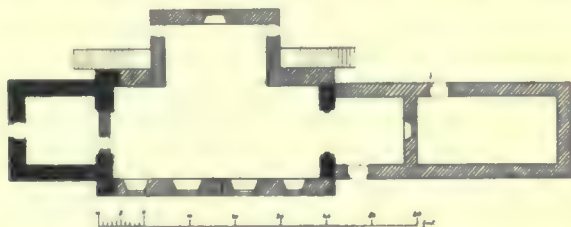
FIG. 183.—Monymusk Church. Plan.

The remains of the ancient Norman church establish the antiquity of the foundation. These consist of the lower part of the tower and the chancel arch. The church, as it now stands (Fig. 183), is a plain oblong modern structure 45 feet in length by 20 feet 3 inches in width internally, with a north wing or aisle, and galleries in the north, west, and east divisions entered from outside stairs. The ancient tower at the west end and the ancient chancel arch at the east end clearly fix the length of the original structure, and the modern side walls probably mark the position of the original side walls. To the east of the chancel arch there is an apartment about 15 feet square, used as a vestry, and in continuation of

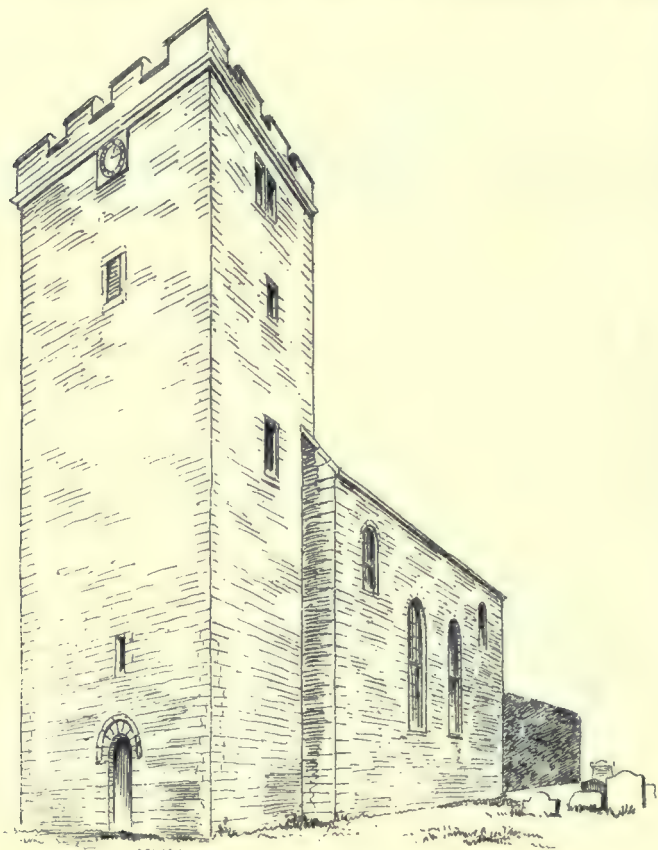
FIG. 184.—Monymusk Church. View from South-West.

The west tower (Fig. 184) is 22 feet by 23 feet externally. It appears to have been almost entirely rebuilt, except the doorway in the west wall, which seems to be ancient. It has plain square jambs and round arch head, with hood mould enclosing the arch stones. The opening in the west wall of the tower leading into the church has been by a round archway 9 feet in width, now built up. This wall has been much altered, but there appear to have been Norman imposts to the arch. The chancel arch (Fig. 185) is 8 feet 6 inches wide. It has had a large attached centre
